Potable Water System Microscopic Particulate Analysis

Stoddard Trailhead

Salmon-Challis National Forest

Walsh Project Number: 6137-010

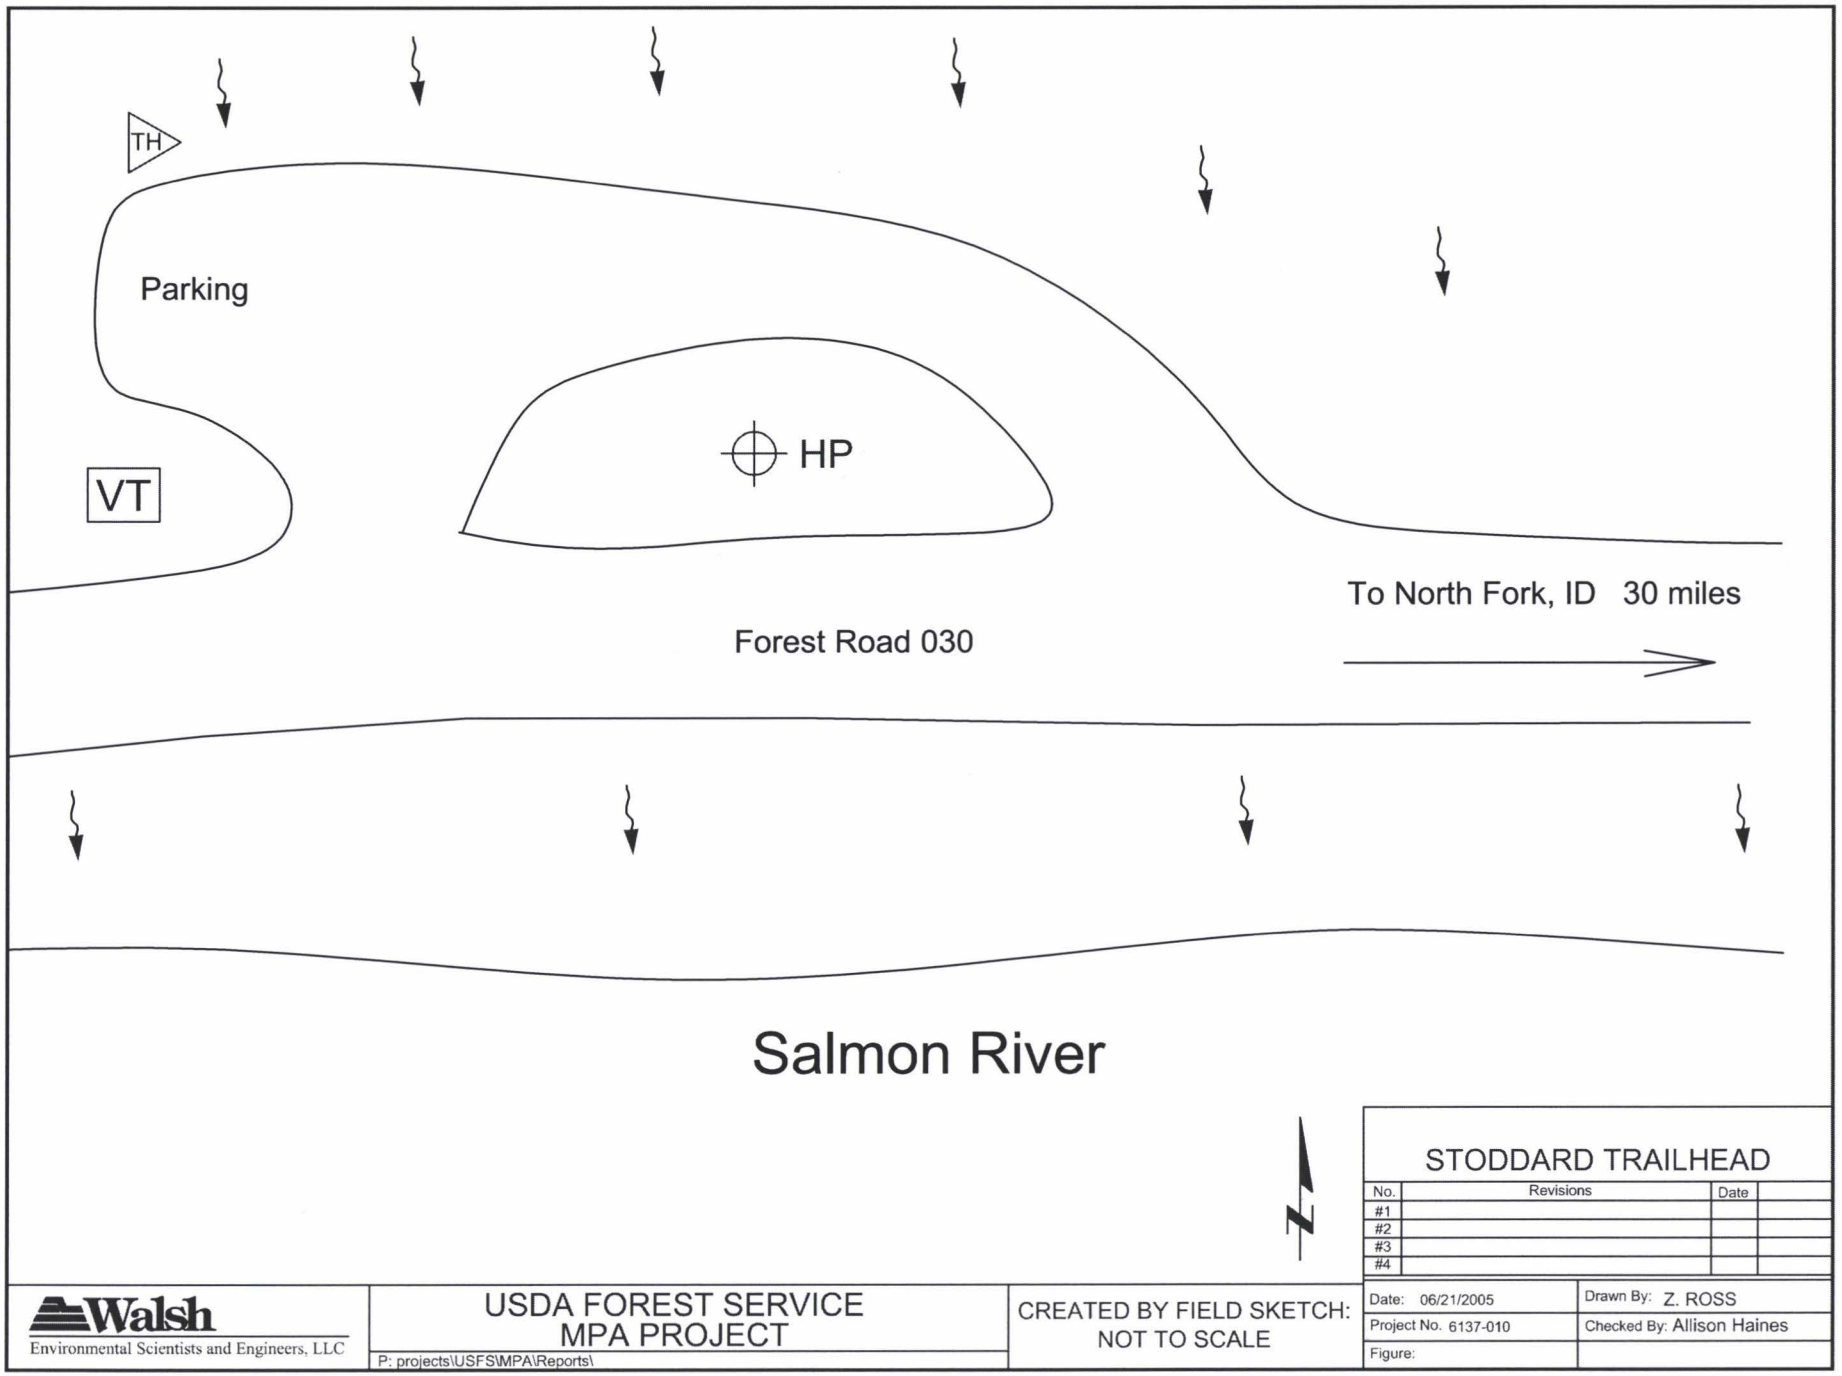
STODDARD TRAILHEAD

A vault toilet located approximately 70 feet west and cross gradient from the well and the Salmon River is located approximately 60 feet south and down gradient from the well.

Improvements: Well casing extends approximately 4 inches above the surrounding concrete slab and should be extended to 18 inches above the natural grade.
